# **BARNSTABLE, MASSACHUSETTS**

## ***HYANNIS WATER SYSTEM***

### ***INSPECTION, ASSESSMENT AND RECOMMENDATIONS OF THE MARY DUNN 1 WATER STORAGE TANK***

**JUNE 2008**

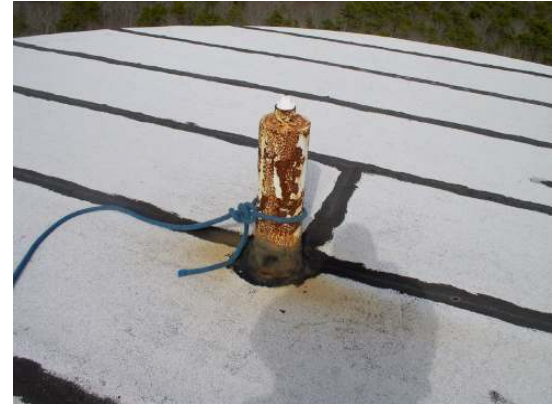
Photograph #1

**Degree of deterioration:** The extent of significant deterioration to date is minimal. The roofing material is still in fair to good condition however the separation at

various seams and nailing points does make it susceptible to wind damage.

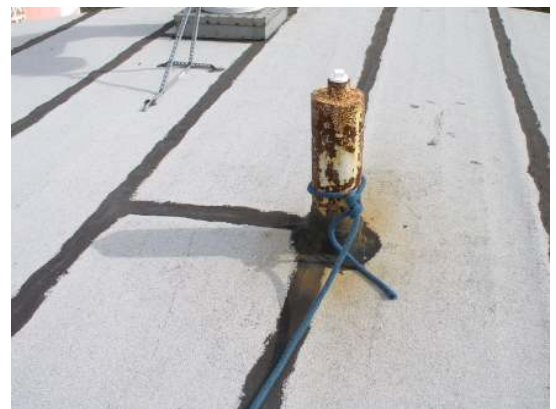
Photograph #9

**General condition of coating:** The coatings on the steel center post appear to be in poor condition, with extensive coating failure and medium to heavy corrosive activity along 75-85% of the visible surfaces as shown in photograph #9.

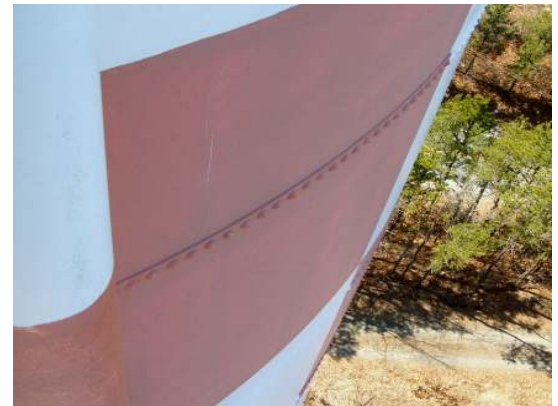
Photograph #13

**General condition of coating:** The protective coatings along the exterior surfaces of the shell were noted to be in very good to excellent condition with at least 95% of the coatings still intact and providing sound protection to the underlying steel surfaces as indicated in photograph #12. There was however, evidence of excessive weathering along the red paneled sections of the checkerboard design. This weathering has resulted in thinning of the finish coat of paint and the exposure of the intermediate coat which was noted to be intact with no further degradation evident at this time as shown in photograph #13 as well as the enclosed video.

Isolated areas of topcoat delamination were also observed along the checkerboard area which has resulting in the exposure of a grey coat of paint. This condition is very minor and appears to be affecting less than 0.5% of the checkerboard surfaces.

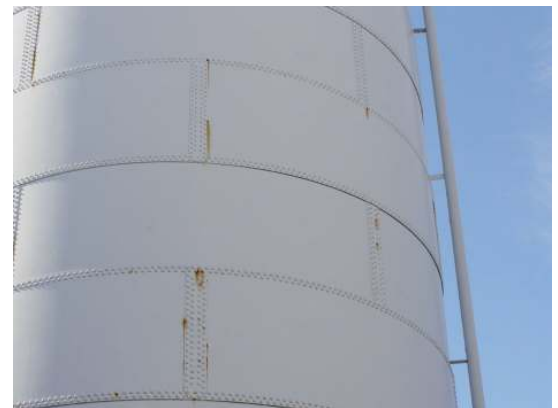
Photograph #14

The remaining surfaces were exhibiting scattered areas of blistered coating which in some areas has fractured resulting in the exposure of the steel substrate. This deterioration appears to be localized to rivet heads and lap seams as well as surfaces immediately adjacent to these areas as indicated in photograph #14. This deterioration appears to be the result of seepage emanating from the interior of the tank when filled which is not uncommon for riveted structures. At this time the tank was empty therefore no active seepage was present.

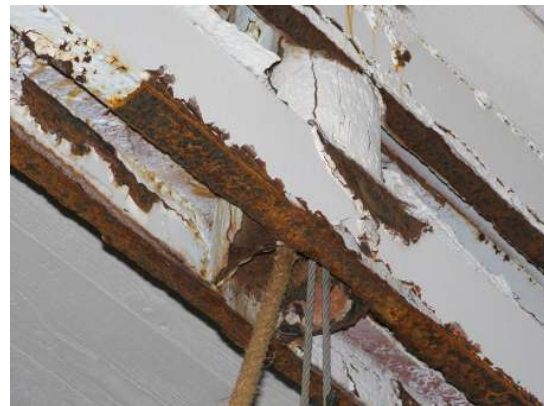
Photograph #41

**Degree of rusting:** At this time, the stratified rust formation appears to be very heavy in areas of the channel beams and center post assembly as illustrated in photograph #41 and is affecting at least 55% of the referenced surfaces. This condition also extends onto the adjacent bar joist surfaces as well as the ends of the joists near the shell perimeter. Overall, as much as 20% of the roof framework is affected with some degree of corrosive activity.

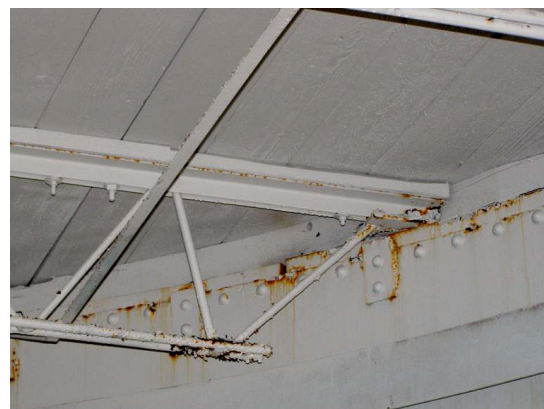
Photograph #42

**Condition of metal:** There is as much as a 30-40% reduction in dimensional size of various components of the center post, channel beams and adjacent joist surfaces. Slight to moderate metal loss, representing 10-20% reduction in dimensional size of the associated surfaces was noted along the outer joist surfaces. However, these surfaces will have to be cleaned of all corrosion products before and accurate assessment of metal loss could be made.

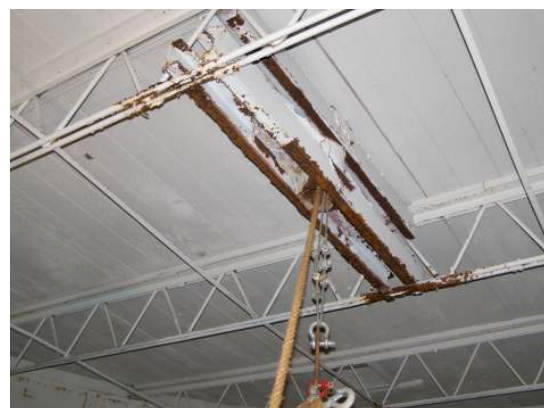
Photograph #43

**General condition of coating:** The coatings along the surfaces of the entire assembly are in very poor condition with extensive coating failure and corrosive activity currently taking place as previously referenced. Even the interior portion of the center rigging post is in poor condition, with widespread cracking and delamination of the coatings and medium to heavy corrosion noted.

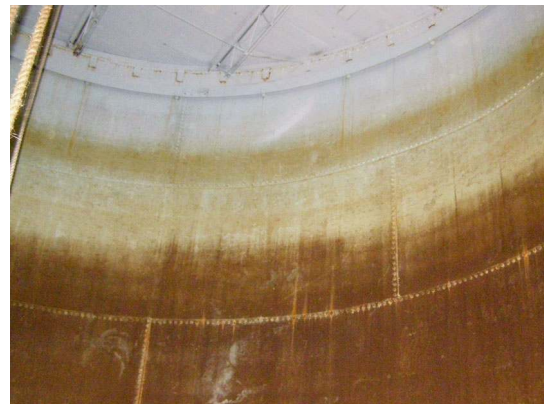
Photograph #44

**General condition of coating:** The top two rings of the interior shell were found to be in excellent condition, with less than 0.1% of the surfaces exhibiting visible corrosive activity. This rusting was primarily located along lap seams, which were not seal coated during the last scheduled maintenance, as were the lower (15) shell rings. At this time, there is no evidence of any active metal loss taking place, nor evidence of any significant past metal loss. Rivet heads in this area were in very good to excellent condition, with 98% of the rivets retaining 95% or greater head dimension. Only isolated rivet heads appear to be exhibiting any metal loss, with less than a 5% reduction in head dimension.

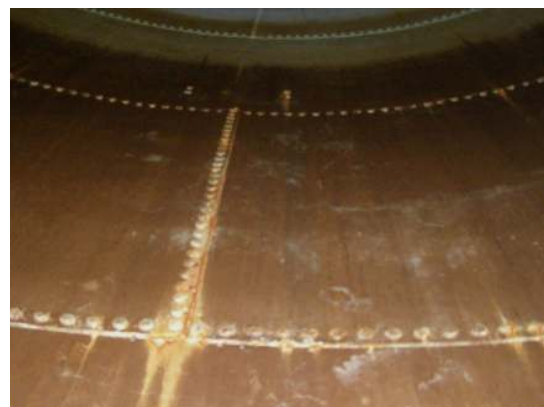
Photograph #45

Shell rings 16-18 were also found to be in generally very good to excellent condition, although a slight increase in overall deterioration was taking place. Approximately 1-2% of the rivets and lap seams along this area, which appears to be the fluctuation zone of the tank, are exhibiting medium to heavy rust formation, primarily along lap seams and previously pitted surfaces as shown in photograph #45. This rusting is primarily of a surface grade, with no appreciable metal loss taking place.

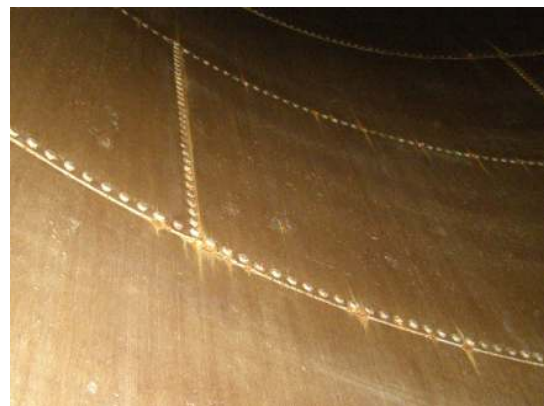
Photograph #46

The lap seams and rivets of rings 16-18 were not sealed with the elastomeric sealant that was applied to the lower fifteen rings, however they are still in very good to excellent condition, and with at least 90% of the rivet heads retaining at least 90% or greater head dimension as shown in photograph #46. Only scattered rivets were exhibiting metal loss with less than 10% reduction in head dimension, primarily due to past metal loss. There is no significant metal loss taking place from active corrosion.

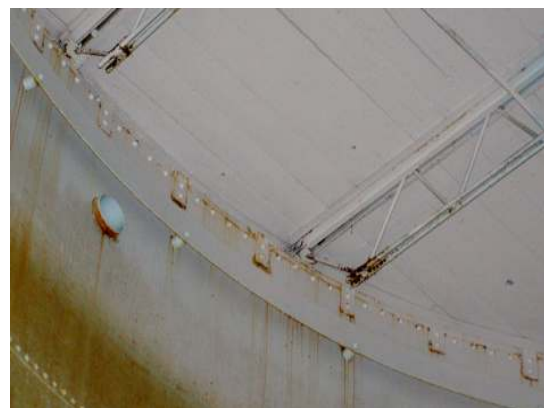
Photograph #53

**Condition of metal:** The referenced item appears to be intact with no significant metal loss observed. Nevertheless this rail should be thoroughly inspected and tested prior to utilizing the rail for rigging purposes.

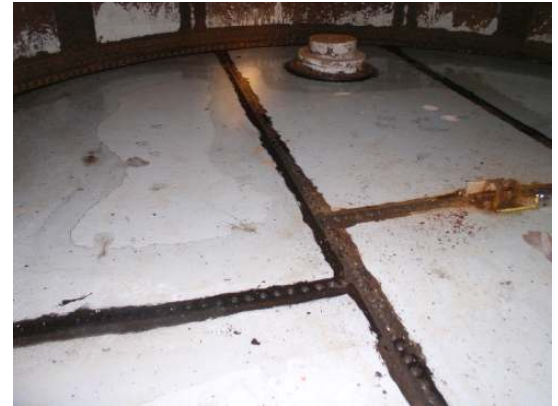
Photograph #54

**Condition of laps and rivets:** Lap seams and rivets appeared to be in very good condition however the Elasto-Shield sealer does impede through assessment.
