Final Report

Stewart's Creek Phase II Technical Memorandum Summary

Prepared For:
Town of Barnstable
230 South Street
Hyannis, MA 02601

Prepared By:
Woods Hole Group, Inc.
81 Technology Park Drive
East Falmouth, MA 02536

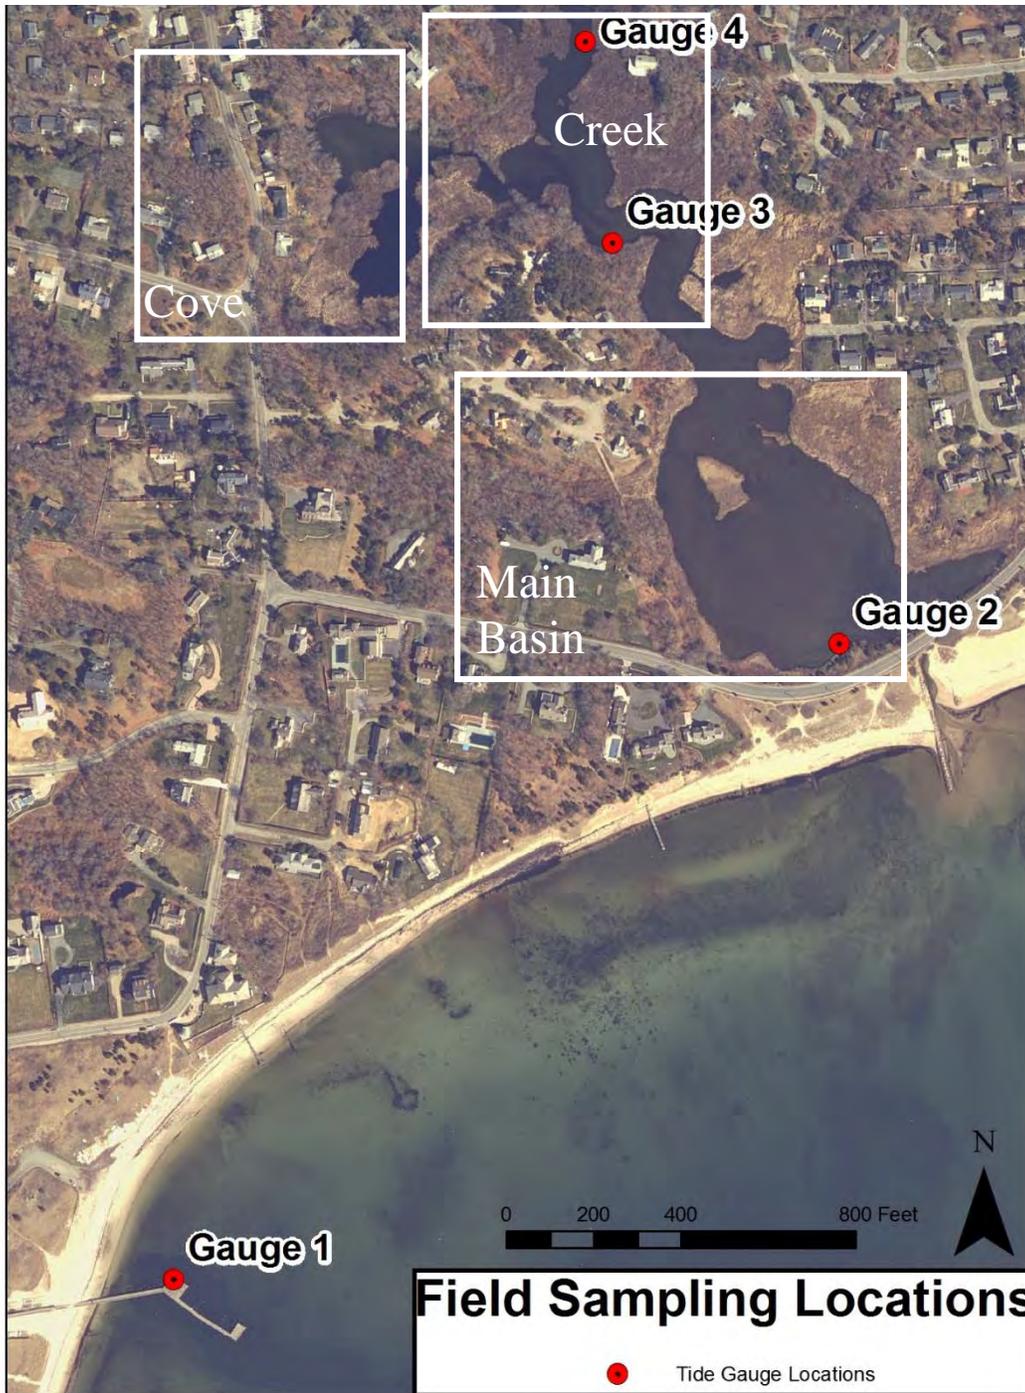
Figure 1. Tide, salinity, and temperature monitoring locations.

The water surface elevation (tide), salinity, and temperature were measured at four (4) locations within the Stewart's Creek system as shown in Figure 1 using In-Situ AquaTROLL 200s instruments. The AquaTROLL 200 incorporates pressure, conductivity, and temperature sensors to accurately calculate water depth, salinity, and temperature. The instruments were synchronized with a universal clock and programmed to autonomously record a time-stamped data point every 6 minutes during the deployment period. The elevation of each instrument was surveyed by the Town of Barnstable Surveyors to reference the water level records to a common vertical datum (NAVD 88). The instruments were deployed from September 15 through October 31, 2015 for a period of 46 days, which captured at least one (1) full lunar tide cycle. Gauge 1 was deployed, with permission, off a piling at the Hyannis Port Yacht Club to capture the exterior forcing tides for Stewart's Creek from within Lewis Bay. Gauge 2 was deployed in Stewart's Creek in the tidal creek upstream of the flood tidal pool to capture the tide signal that immediately enters the Stewart's Creek system. Gauge 3 was deployed upstream of the tide gate between the main basin and Cove area to capture the tide as it propagates from the main basin and enters the creek portion of Stewart's Creek. Gauge 4 was deployed upstream of the Cove as far north as the condition of the marsh would allow (where the water depth was sufficiently deep to deploy the equipment at low tide) to evaluate the tides reaching the upper portion of the creek.

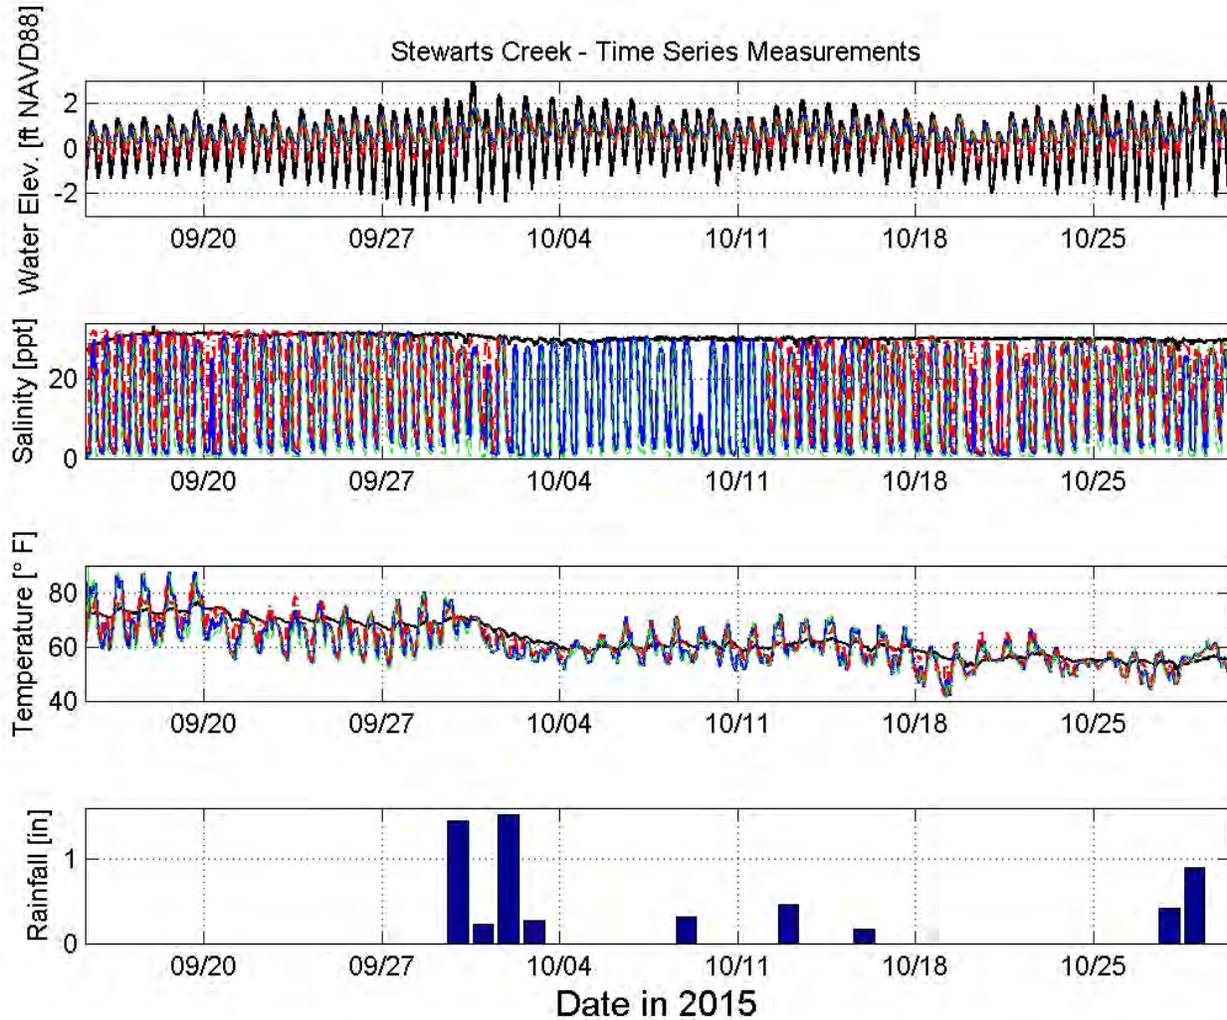
Figure 2. Times series measurements showing water surface elevation (top), salinity (second), temperature (third), and rainfall (bottom) at the four monitoring locations at Stewart's Creek including Lewis Bay (black), lower basin of Stewart's Creek (red), mid-creek (blue), and upper creek (green).

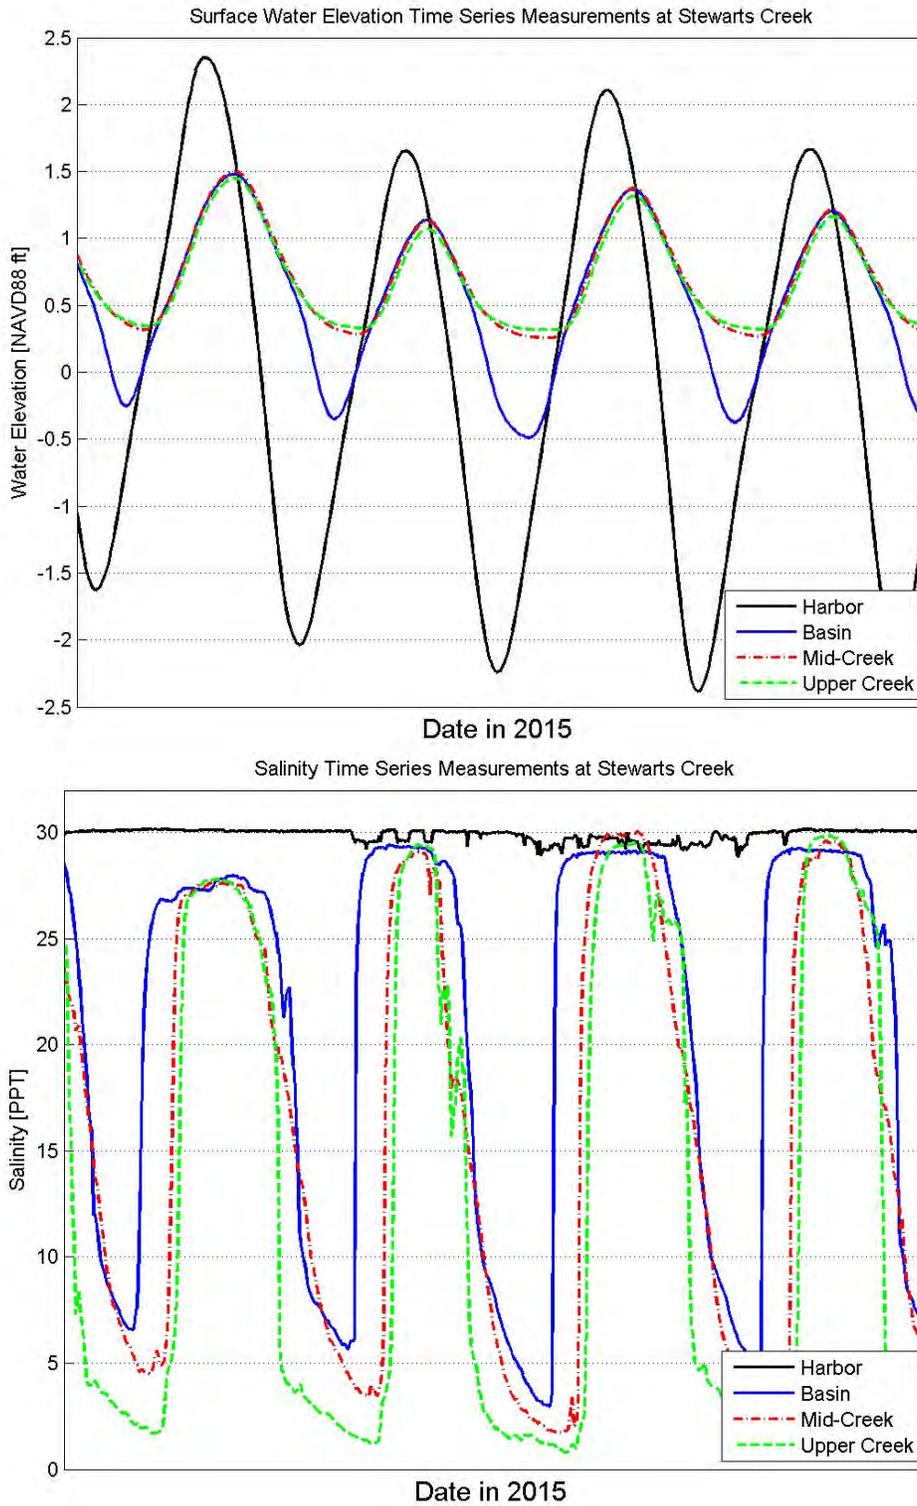
Figure 3. Example of spring tide conditions for water surface elevation (top) and salinity (bottom) at Stewart's Creek.

Greater insight into the tidal dynamics within the Stewart's Creek system is revealed through examination of the measured time series data over a shorter period of time. Figures 3 and 4 illustrate a 2-day sample zoom view of the water surface elevation and salinity time series data during a representative spring and neap tide, respectively. Figures 3 and 4 show that during both spring and neap tides there is significant attenuation of the high tide from Lewis Bay (black line) to Stewart's Creek (blue, red and green lines). There is a reduction of peak water surface elevation at high tides and a delay in the time high tide occurs (phase lag) within the system. Although the elevation of high tide matches well at the three locations within Stewart's Creek, the elevation of low tide increases within the system. Salinity oscillates from nearly salt to nearly fresh water with each change of the tide, typical of an estuary system.

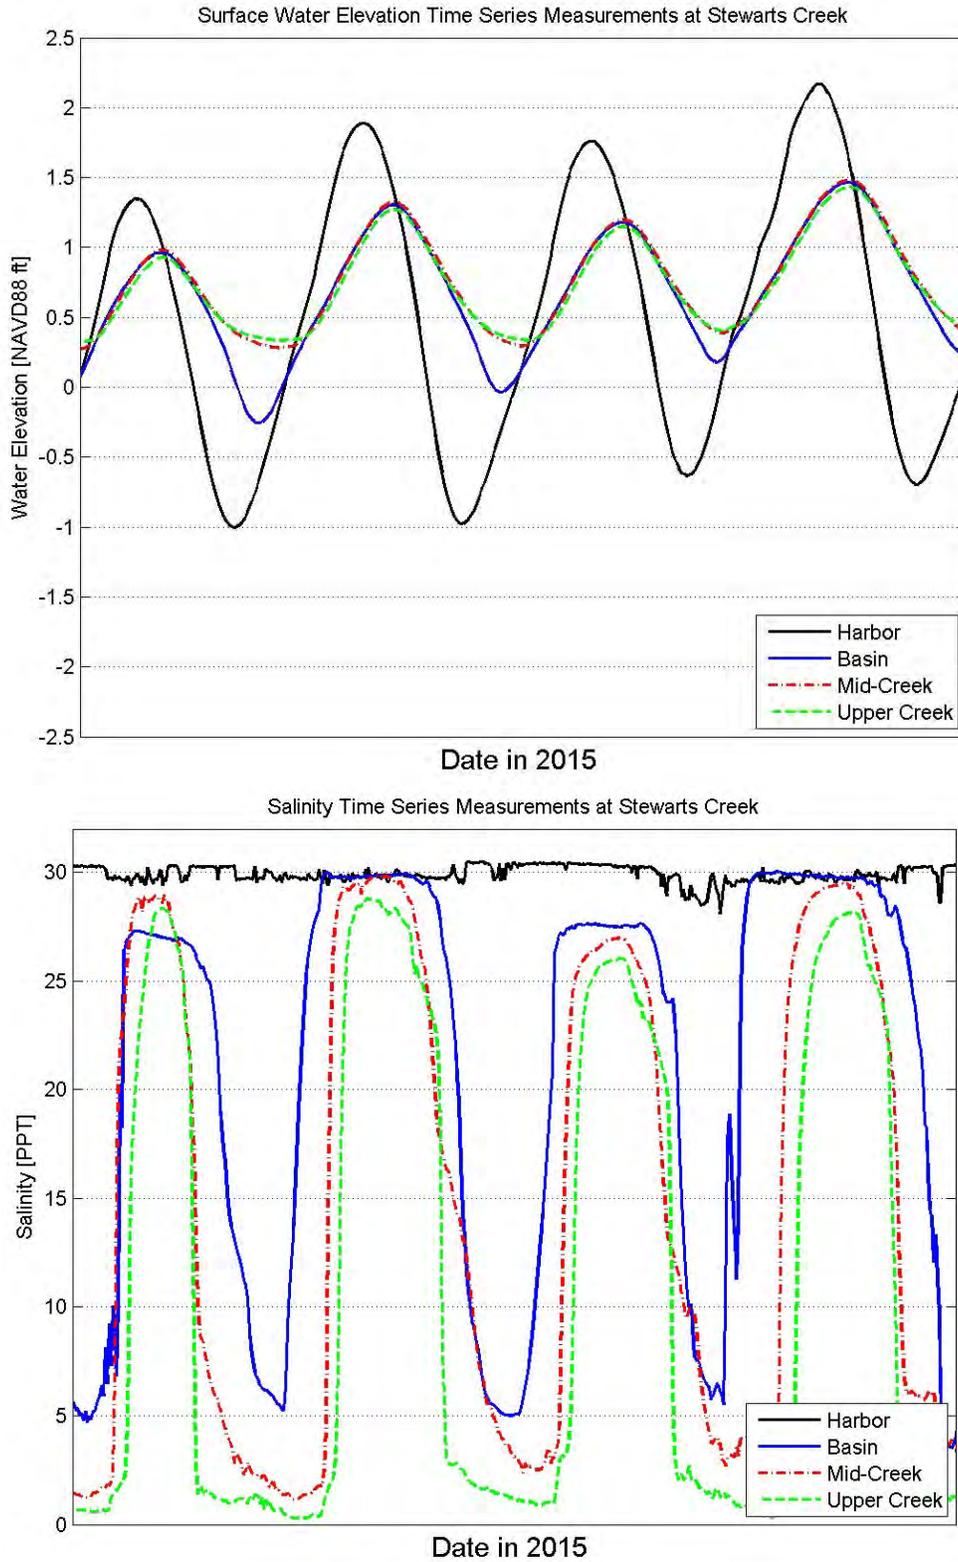
Figure 4. Example of neap tide conditions for water surface elevation (top) and salinity (bottom) at Stewart's Creek.

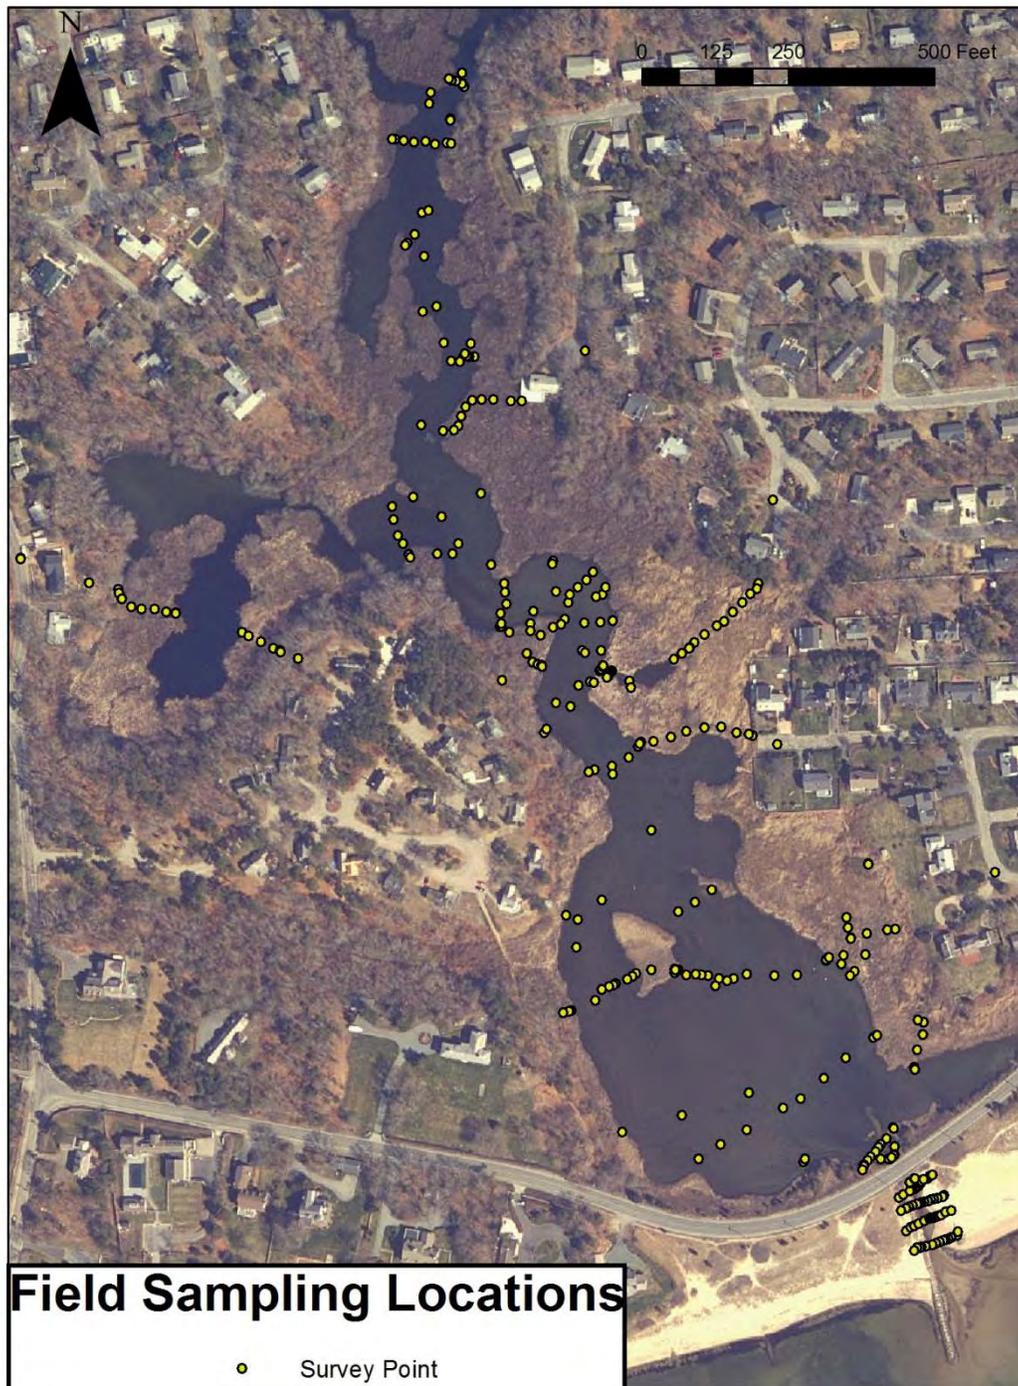
Figure 5. Survey data points collected by the Town of Barnstable department of surveying.

Elevation data for Stewart’s Creek were updated using survey data collected by the Town of Barnstable department of Surveying, along with the latest available LIDAR data (2011). The Survey Department used a Trimble R10 RTK GPS to occupy similar cross-section locations as surveyed by USACE during the pre-construction monitoring as shown in Figure 5.

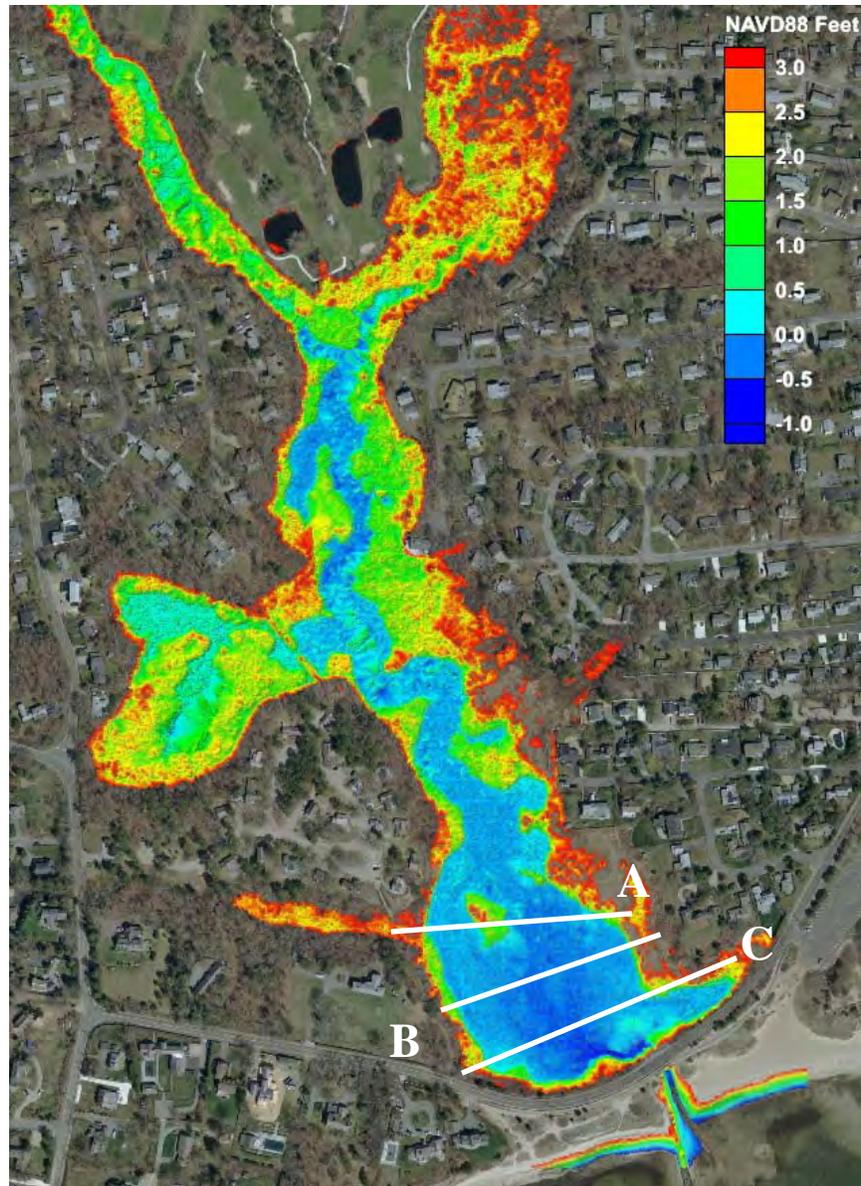
Figure 6. Composite map of LIDAR data adjusted using Town Survey Data.

adjusted, where necessary, using the survey data collected by the town. A combined survey and LIDAR elevation data referenced to NAVD88 (feet) is shown in Figure 6.

From this data, three (3) cross sections were extracted based upon the original USACE survey cross-section locations as indicated by the white lines in Figure 6 for Cross sections A (upper basin), B (middle basin), and C (lower basin). A depiction of the USACE pre-construction cross sections versus the post-construction cross sections are shown in Figure 7 below. The figure indicates that about a 0.5 – 1 ft layer of sediment has eroded away in the middle (B) and lower portion (C) of the basin. The upper basin, Transect C, has been relatively stable although the two creek channels on either side of the island appear to have scoured by up to a foot. While these

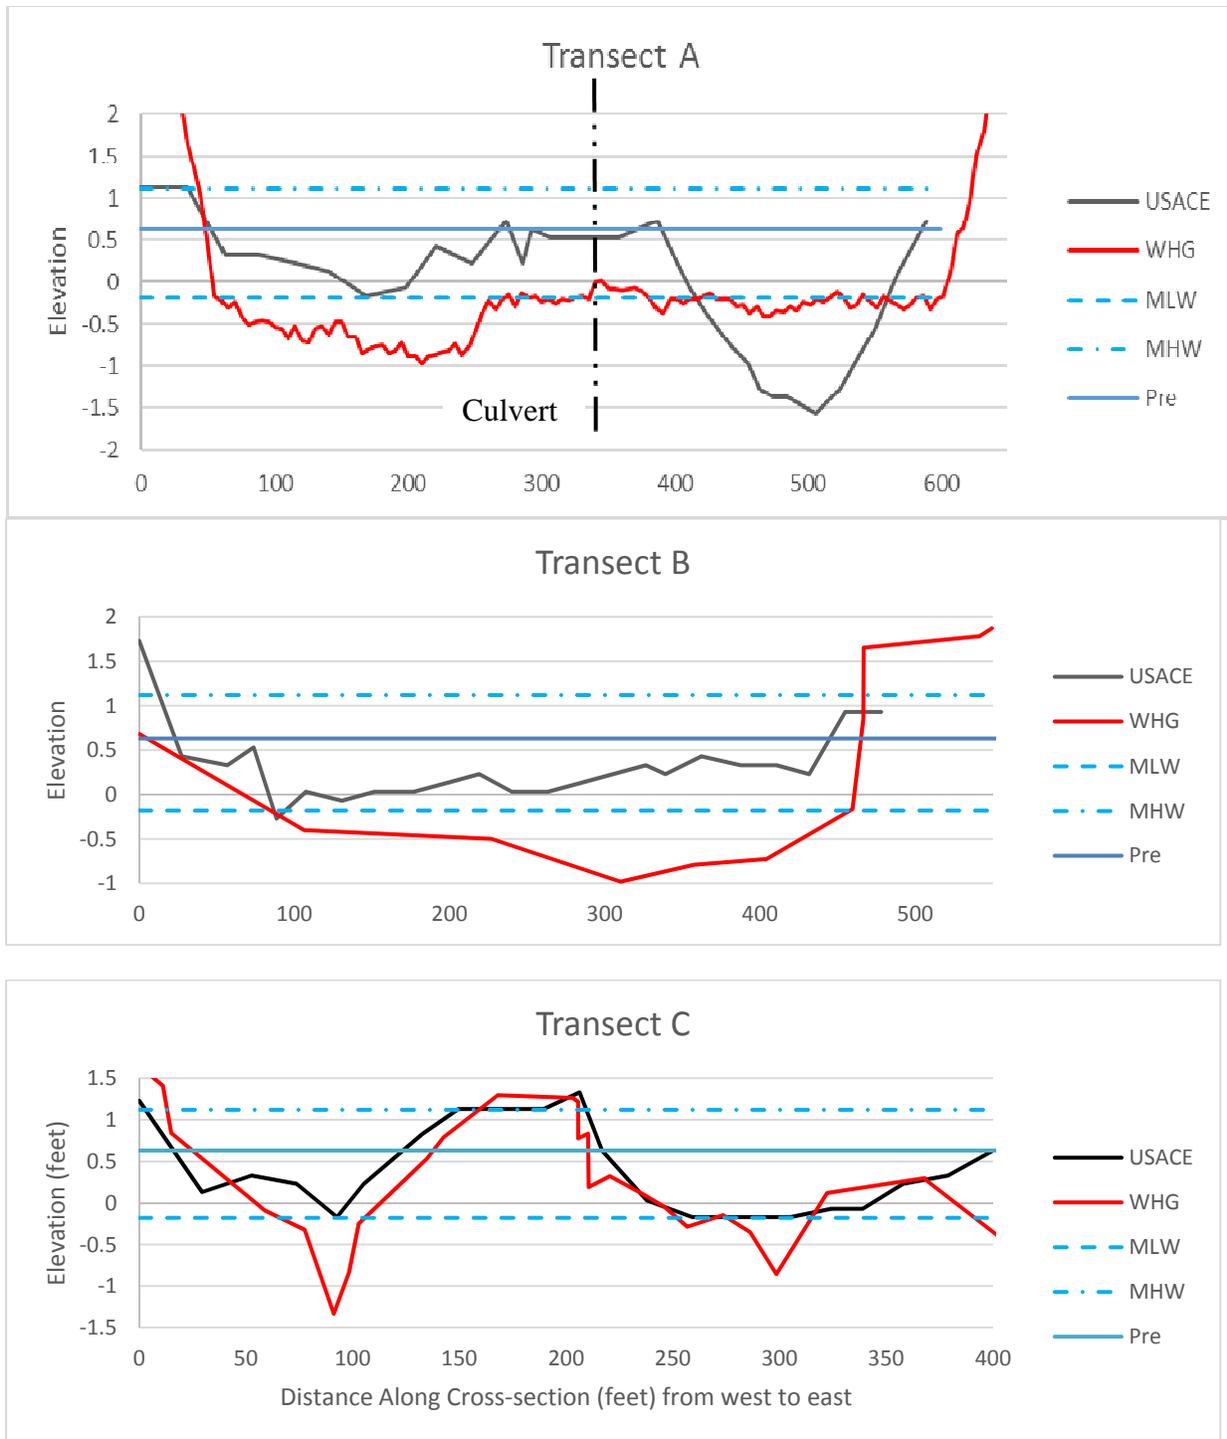
Figure 7. Cross section from lower (top), middle (middle), and upper (bottom) basin of Stewart's Creek.

results would seem to indicate that the ~1ft top layer has scoured in the Stewart's Creek basin, the sediment cores appear to indicate that this layer is still present. It is quite possible that some of this fine top layer was removed though just not completely.

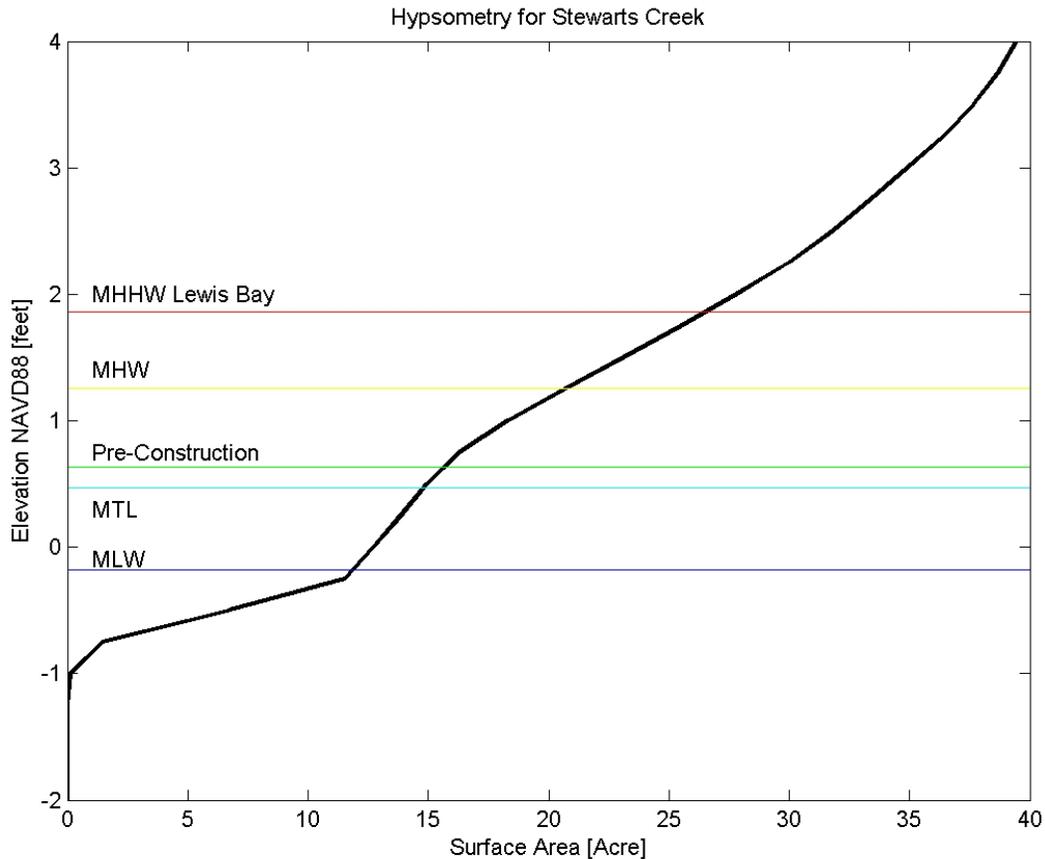
Figure 8. Hypsometric Curve showing the area of inundation for Stewart’s Creek at various tidal stages.

From the combined bathymetric and LIDAR data, a hypsometric curve was generated for Stewart’s Creek. The hypsometric curve provides information to estimate the area of the basin inundated for a given water surface elevation or tidal stage. For instance, Figure 8 shows the estimated wetted area at MHW is ~20 acres, whereas the area inundated at MLW is ~12 acres. The intertidal area, then, is around ~8 acres. Figure 8 also shows if the MHHW level in Lewis Bay was somehow introduced to Stewart’s Creek (e.g., no tidal restriction at all), the estimated wetted area could increase to 25.8 acres.

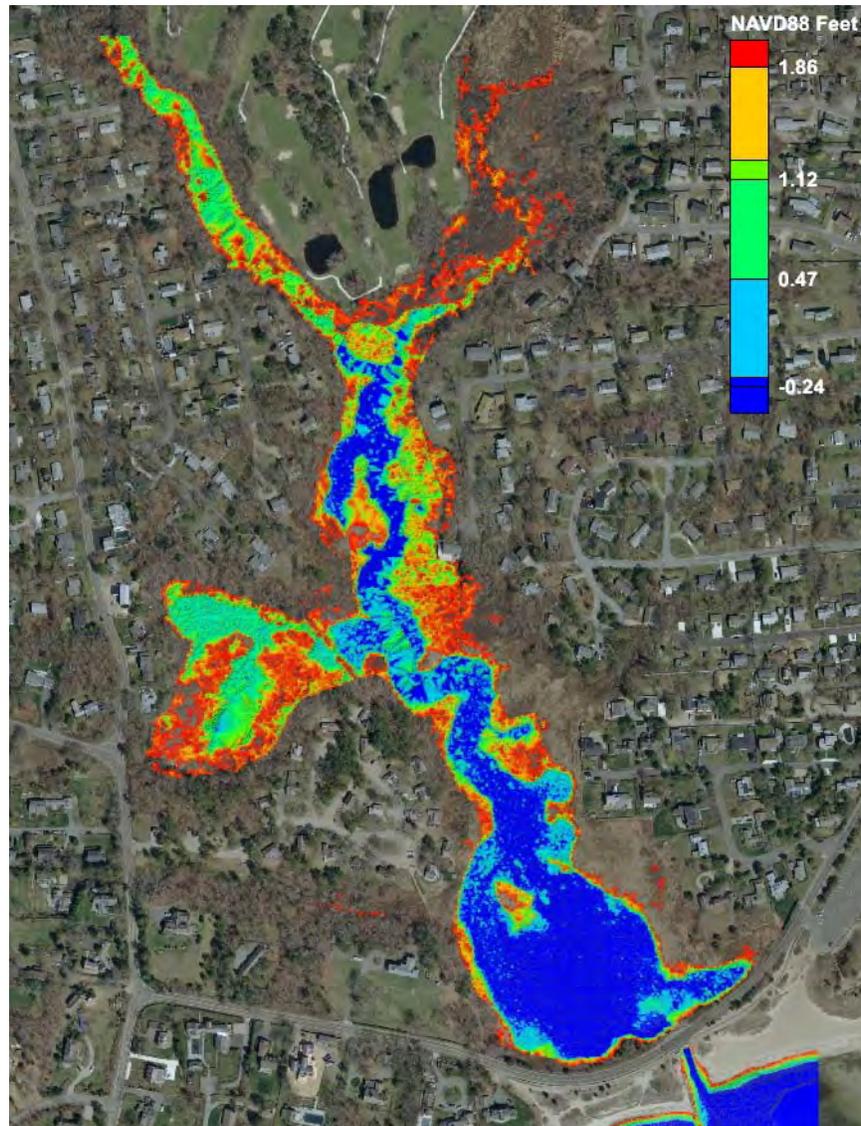
Figure 9. Areas of inundation at MLW (blue), MTL (light blue), MHW (orange), and MHHW in Lewis Bay (Red).

Figure 9 below indicates areas of inundation (flooding) during various phases of the tidal cycle including inundation at: MLW (dark blue); MTL (light blue); MHW (orange); and if the MHHW in Lewis Bay (red) somehow entered the system. This figure reveals several interesting trends at Stewart’s Creek. The first is that a typical MHW reaches far up Stewart’s Creek past the fork at the Golf Course, which means tidal flow has been restored up a significant portion of the creek. At low tide (MLW), the main stem of the creek and basin are still flooded, but the eastern cove has gone dry, a trend that has also been noted by the residents living there. Significant dampening of the tidal signal from Lewis Bay into Stewart’s Creek was noted previously, and the potential for further tidal restoration into Stewart’s Creek from Lewis Bay

was evaluated. The figure shows that even if the full high tide from Lewis Bay at MHHW entered Stewart's Creek that there would not be a significant gain in the inundated area as the red and orange areas are blended together.

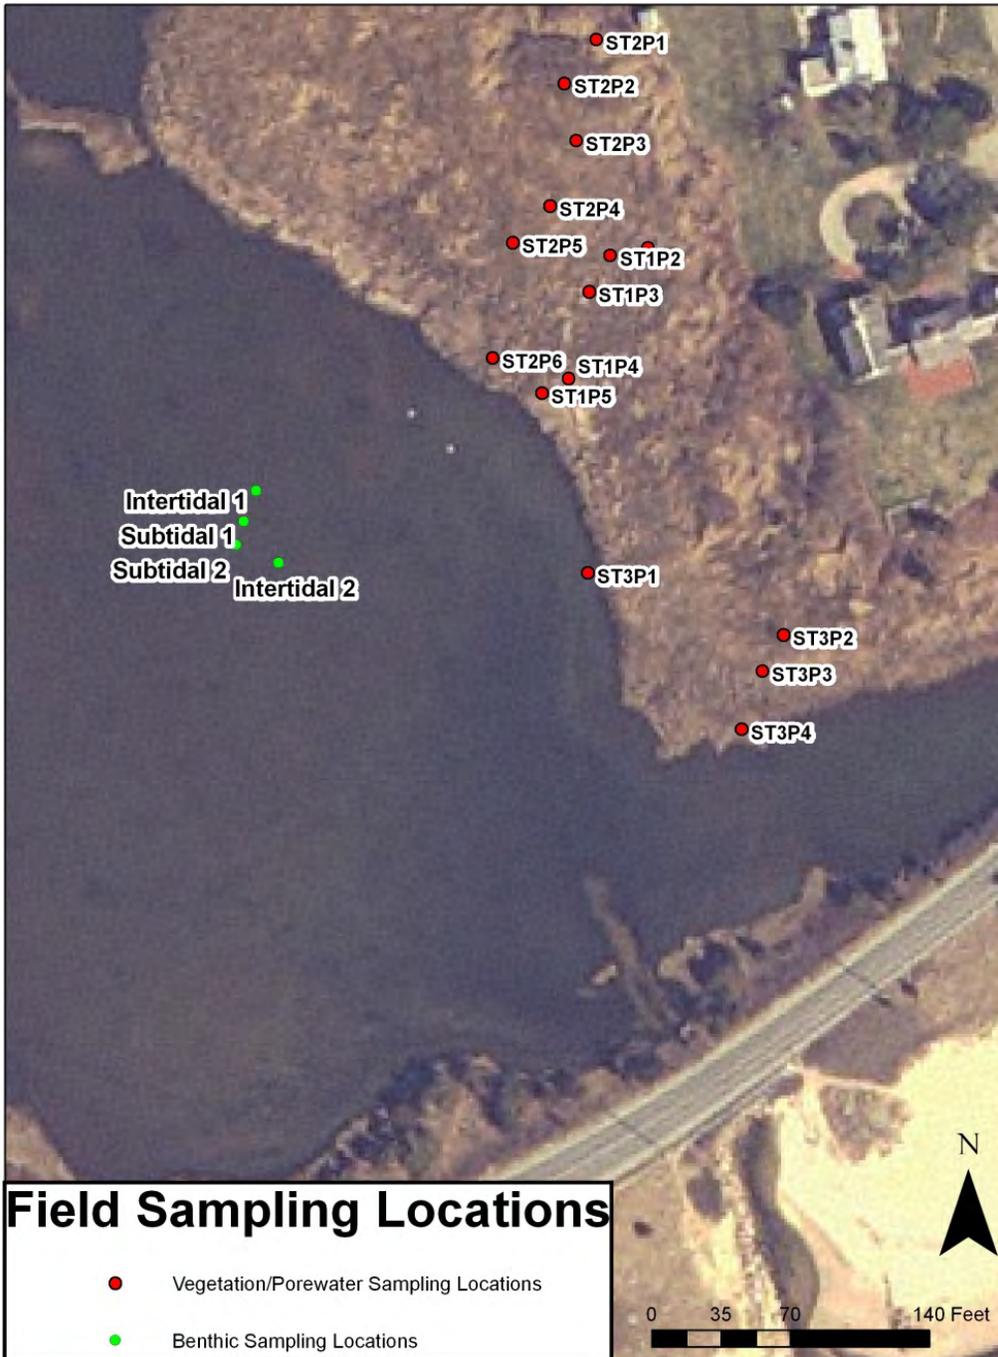
Figure 10. Benthic and vegetation post-construction monitoring locations.

Figure 10 shows a map of the vegetation transects surveyed post-construction by our project partners, the Cape Cod Conservation District (CCCD). Prior to the restoration, this series of sampling stations were established in both Stewarts Creek and Halls Creek to establish a baseline of existing conditions. The initial vegetation sampling in Stewarts Creek showed no desirable marsh plain vegetation at any of the sampling stations.

The results of the year-2 monitoring showed there has been little change in vegetation at these locations. During the year-2 monitoring 15 stations (red dots on Figure 10) were sampled in the Stewarts Creek system. At each station the percent cover of each species was noted and the stem density was recorded. Only one station recorded an increase in *Spartina alterniflora* (low marsh species) and *Spartina patens* (high marsh species). This station was located closest to the culvert. All of the other 14 sampling stations were dominated by *Phragmites* and other non-desirable fresh water species. None of these 14 stations had any desirable marsh species.

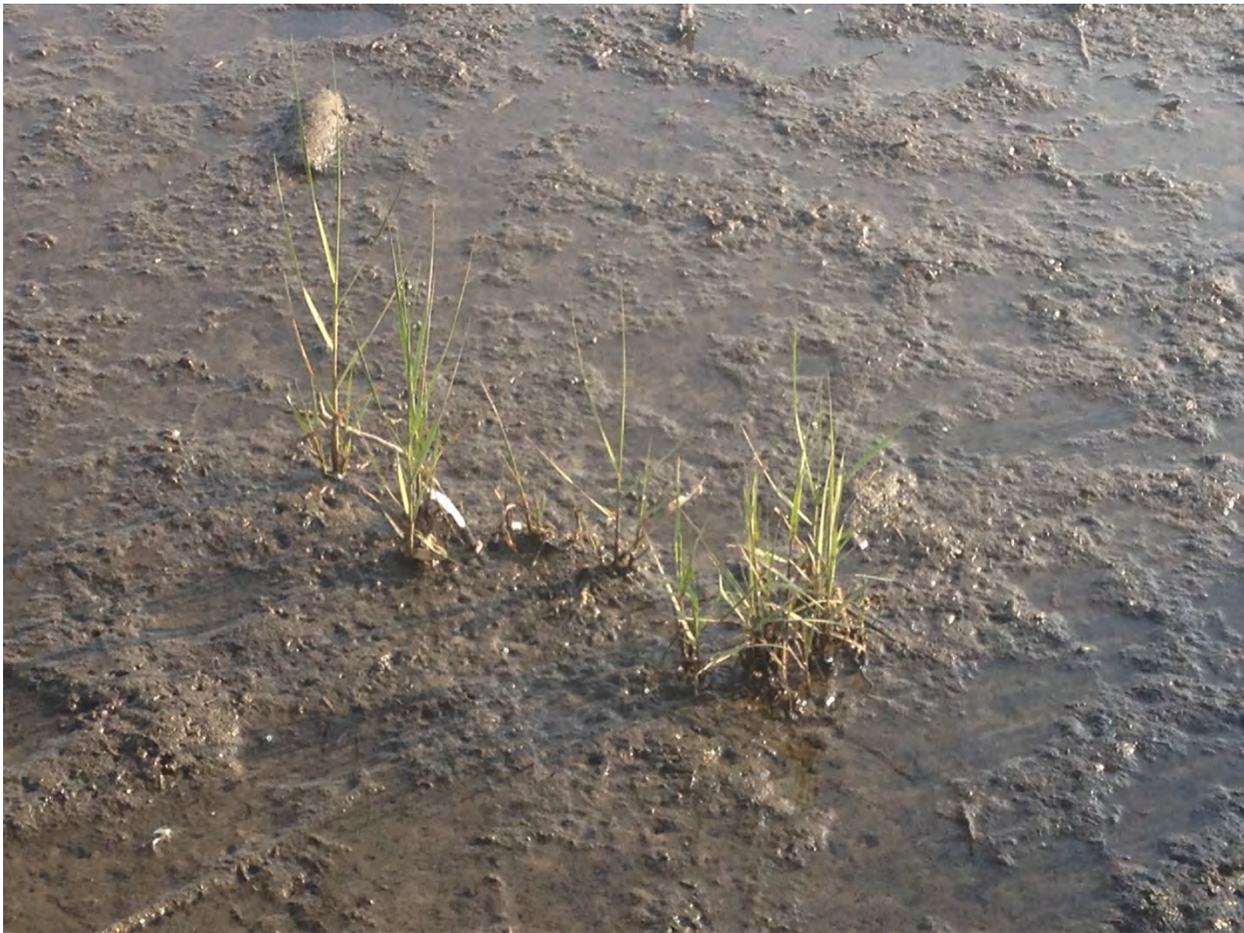
Figure 11. Emergent salt marsh vegetation observed in Stewarts Creek (July 2016)

Figure 11 illustrates initial emergence of *Spartina alterniflora* on the mudflats exposed as a result of the expanded tidal range introduced to Stewarts Creek by the new culvert system. This was a new observation between the Draft and Final Reports. These areas can potentially expand with appropriate tide, velocity, and salinity conditions, as well as seed source. Figure 12 shows an area of vegetation die-back, believed to be previously freshwater species that now are exposed to salt water. The evolution of these areas is a key component of the project to ensure salt marsh species are established instead of invasive species, such as *Phragmites*. These areas should be closely monitored, perhaps with supplemental support from an outside grant agency. There are unique characteristics of Stewarts Creek and its response to the new culvert that have potential wider utility for planning other similar future projects.

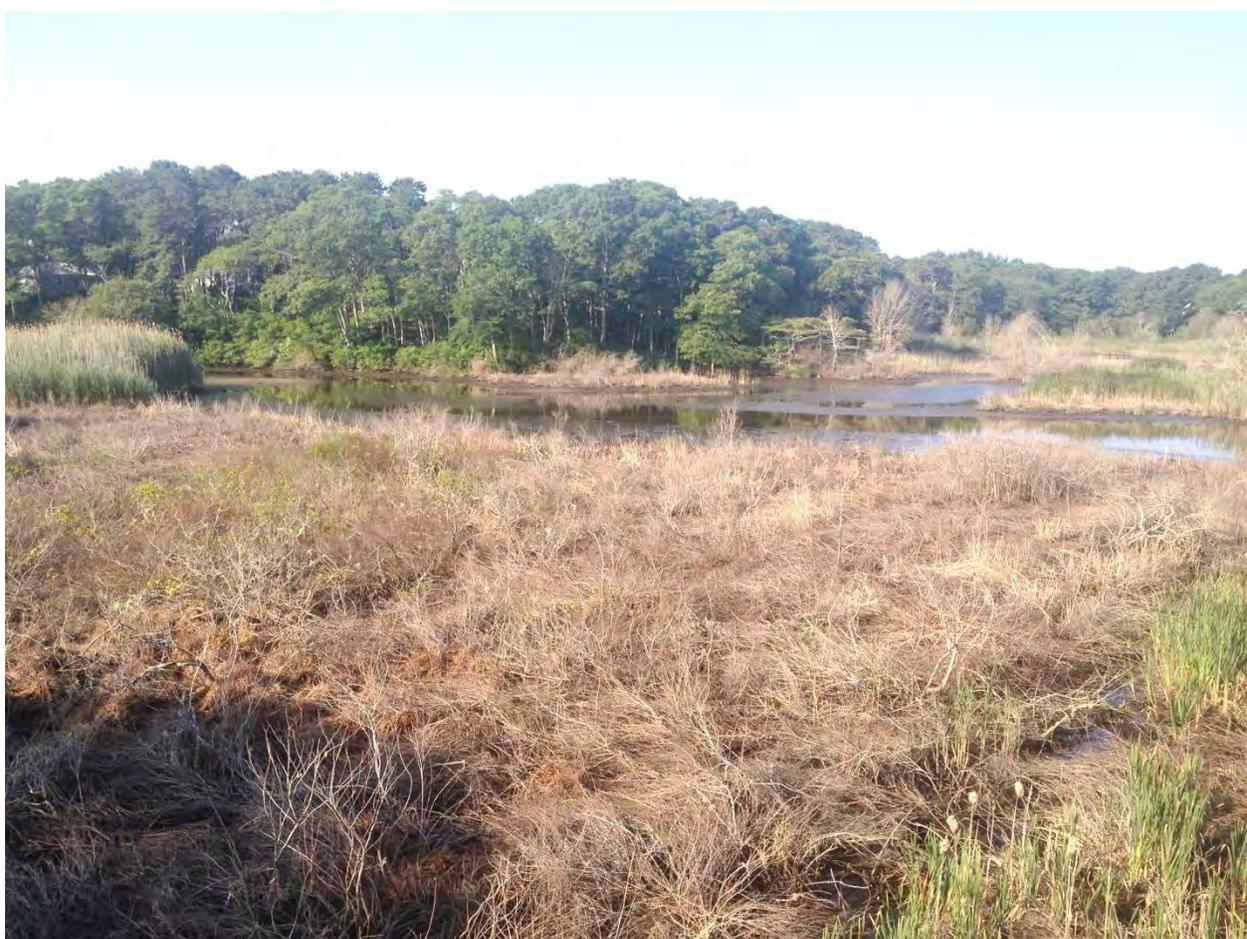
Figure 12. Area of vegetation change with previous freshwater species dying back.

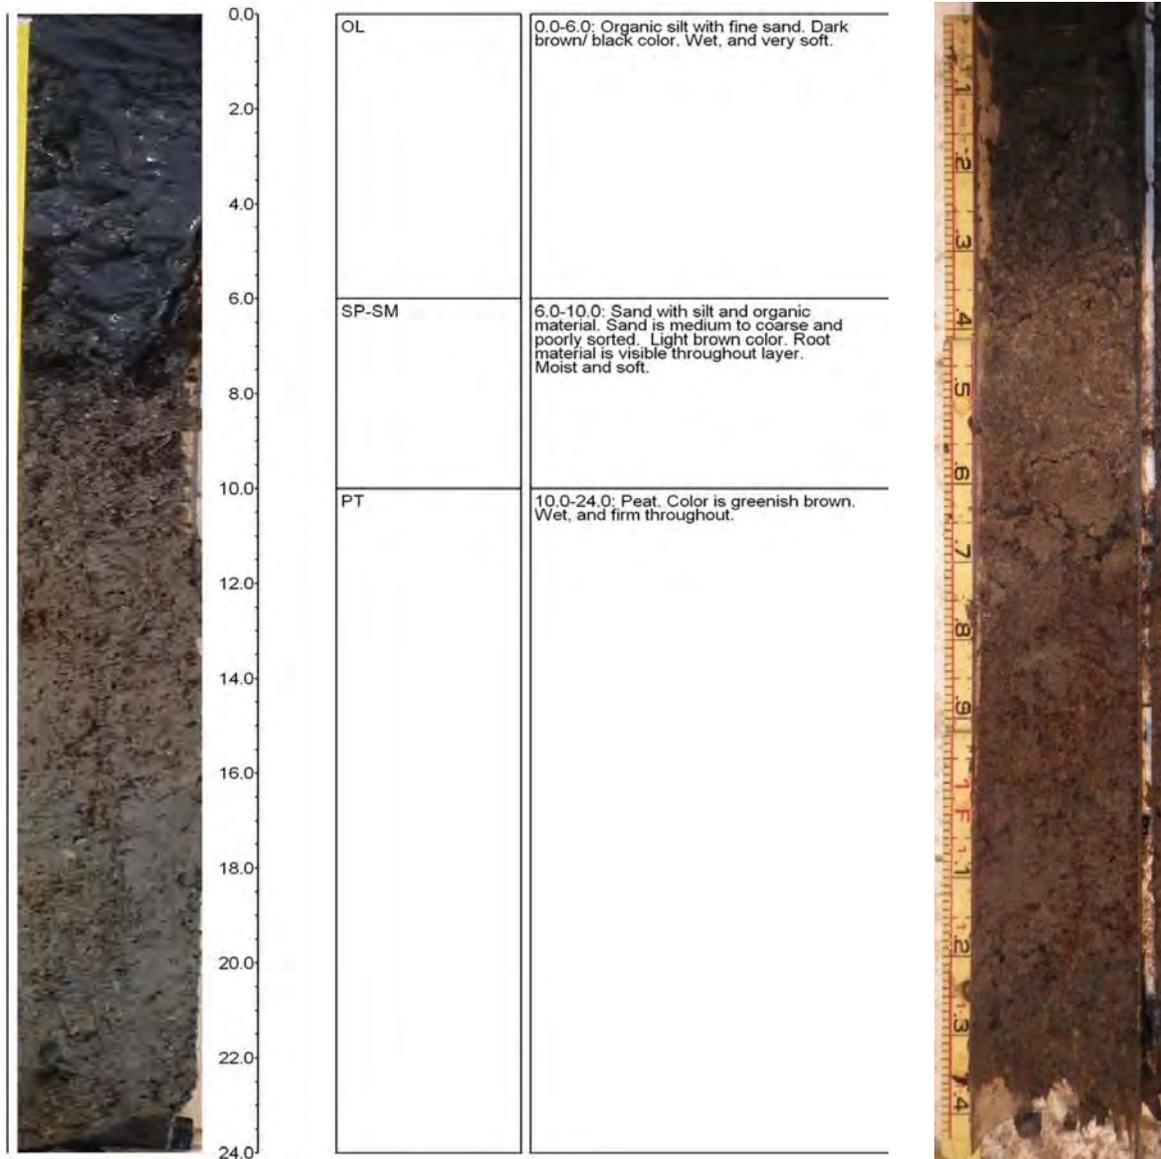
Figure 13. Comparison of a pre-construction sediment core collected by the USACE (left) to the post-construction sediment core collected by the Woods Hole Group, Inc. (right). Composition is very similar between pre- and post-construction cores.

Figure 13 shows a comparison of a typical pre-construction core log (left) collected by the USACE versus a typical post-construction core taken by Woods Hole Group (right). The pre-construction coring results indicated there was a 0.5 – 1 ft layer of fine, silty sediment overlying a sandy layer with some cores showing a peat layer underneath as well. The post-construction coring results indicate that a similar layering composition is still present.
