# **BARNSTABLE, MASSACHUSETTS**

## ***HYANNIS WATER SYSTEM***

### ***INSPECTION, ASSESSMENT AND RECOMMENDATIONS OF THE MARY DUNN 1 WATER STORAGE TANK***

**JUNE 2008**

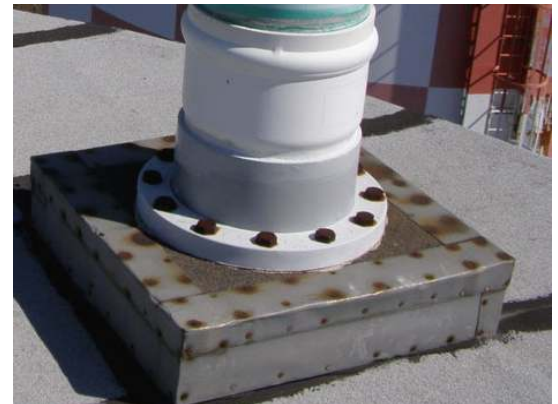
Photograph #5

The bolts that secure the base of the PVC venting pipe to the vent hatch cover are exhibiting a heavy degree of rusting, with no appreciable metal loss. The venting hatch is also in very good condition, although widespread light to medium corrosion is evident along all nail heads of the cover and raised neck as shown in photograph #5.

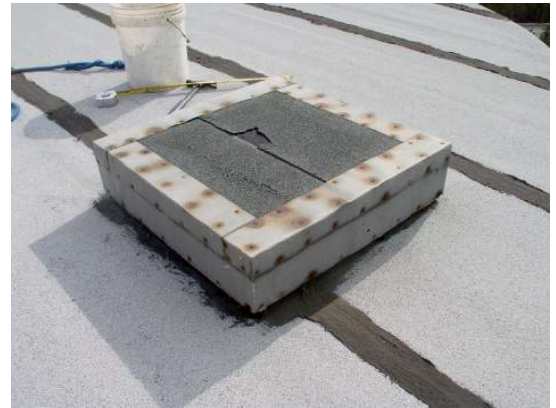
Photograph #7

**General condition:** The roof hatch appears to be in very good condition, with no significant deterioration of the raised neck or the fitted cover. There are minor tears and one small missing section of the top layer of shingles as shown in photograph #7. The exposed underlying layer of tar paper does not appear to have been compromised.

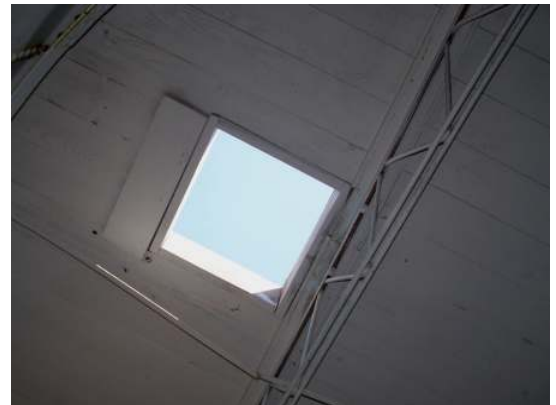
Photograph #8

The majority of all securing nails on the exterior of the hatch cover are now exhibiting light to medium corrosion. The interior of the wood cover and raised neck are in very good condition, with no significant dry rot or splitting of the wood noted. It was also noted that the interior surfaces have been coated with a white paint that appears to be in sound condition as indicated in photograph #8.

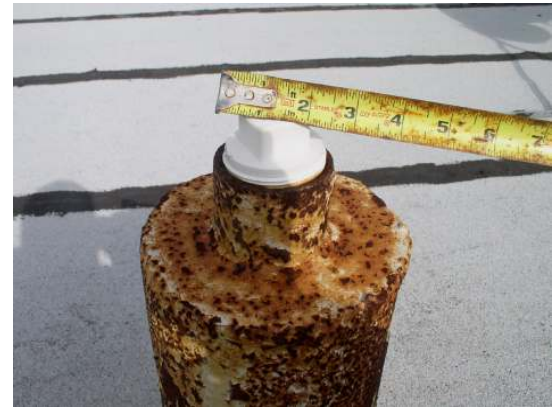
Photograph #10

**Condition of metal:** The center post still appears to be structurally capable of supporting at least light loads however evidence of metal loss along the interior surfaces would suggest the structural integrity has been compromised.

Furthermore the center post is secured in place by additional structural members attached to the bar joists which support the roof. This structure is exhibiting substantial corrosive activity and metal loss as further detailed in the "Interior Roof" section of this report.

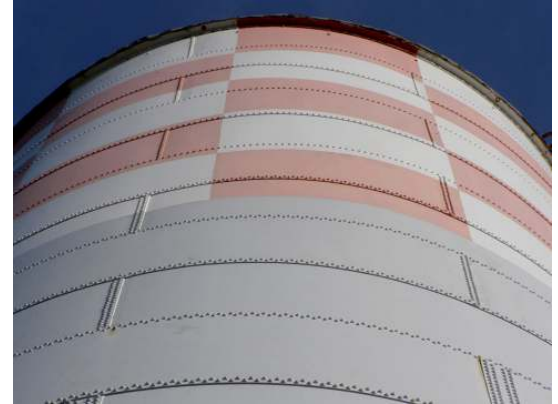
Photograph #12

**General condition of coating:** The protective coatings along the exterior surfaces of the shell were noted to be in very good to excellent condition with at least 95% of the coatings still intact and providing sound protection to the underlying steel surfaces as indicated in photograph #12. There was however, evidence of excessive weathering along the red paneled sections of the checkerboard design. This weathering has resulted in thinning of the finish coat of paint and the exposure of the intermediate coat which was noted to be intact with no further degradation evident at this time as shown in photograph #13 as well as the enclosed video.

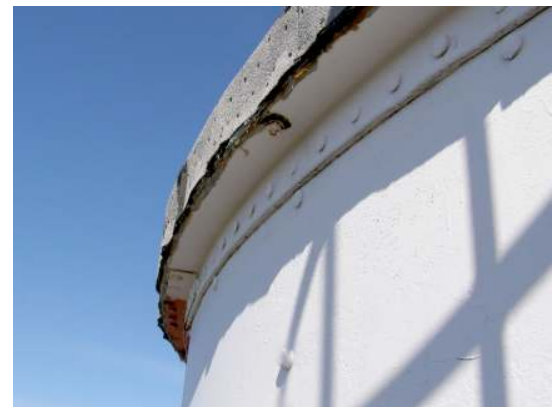
Photograph #17

**General condition of coating:** The top of the shell is equipped with an L-angle with the horizontal leg extending outwards as shown in photograph #17. The coating along the visible surfaces of the rim angle is in generally good condition with the exception of the leading edge of the horizontal leg as well as scattered areas along bolted connections, rivets and splice connections. There is also evidence of coating failure and rust formation along the bottom leading edge of the vertical leg of the angle.

**Degree of rusting:** There is evidence of medium to heavy rust as well as isolated areas of stratified rust formation along the leading edge of the horizontal leg and along

scattered bolted connections. Furthermore, there is evidence of light to medium rusting along the junction of the vertical leg of the angle to the shell.

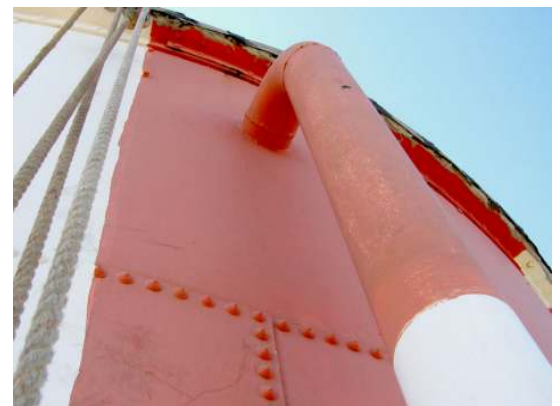
Photograph #20

**Type:** The overflow system is comprised of a 6"Ø steel pipe that exits through an elbow from the top shell ring as shown in photograph #20, and then extends vertically down the shell to the third shell ring. The steel pipe is then coupled through a flange assembly to a PVC pipe that terminates in a 45° elbow approximately 20" above grade. The base of the pipe is supported by a U-bolt and pipe support bracket from ground level, and the elbow opening is covered with a stainless wire mesh screen.

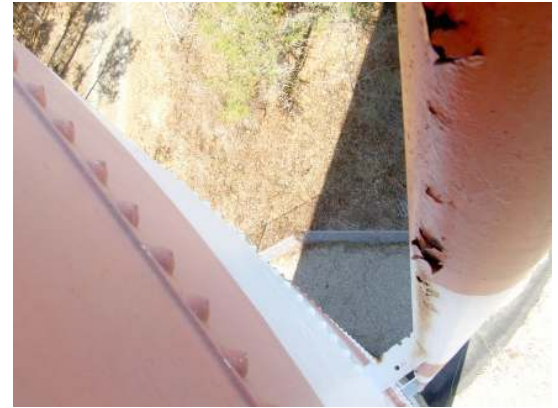
Photograph #21

exception of scattered crazed cracking and coating delamination taking place along approximately 15% of the referenced surfaces. The majority of this deterioration is along the backside of the pipe and has resulted in the exposure of the steel substrate and subsequent medium to heavy rusting as indicated in photograph #21.

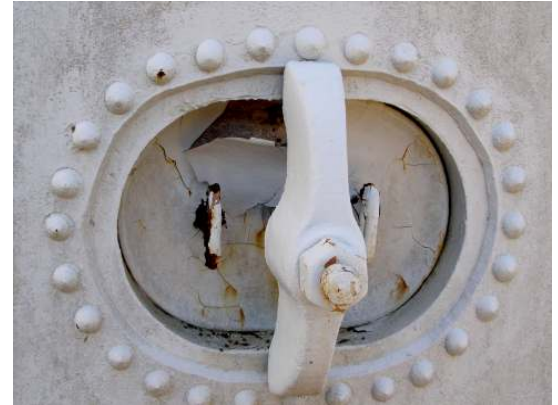
Photograph #24

**General condition of coating:** The coatings along the oval manhole are exhibiting extensive cracking and delamination primarily along the cover as shown in photograph #24. The delamination has resulted in the exposure of a previously applied coating system consisting of an aluminum coat of paint as well as an orange colored primer suggesting that at least the primer may be lead bearing. The coatings along the round manhole and reinforcement pad are in generally very good condition with at least 95% of the coatings still intact and providing adequate protection. The remaining surfaces are exhibiting scattered areas of coating failure and subsequent rust formation along the hinge assembly, the outer edges of the cover and flange assembly as well as the exposed bolt holes and underside of the neck to reinforcement pad connection.

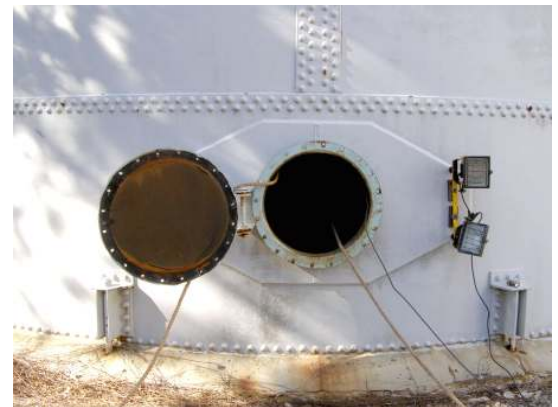
Photograph #25

**Degree of rusting:** Medium to heavy rust and stratified rust formations are affecting 10% of the oval manhole surfaces with the majority of this rusting along the manhole cover handles. Light to medium rusting along with a few scattered areas of heavy rusting were observed along no more than 5% of the referenced surfaces.

**Condition of metal:** Both manholes are in generally very good condition with no significant metal loss taking place except for the handle assemblies along the original manhole cover. One handle is exhibiting moderate to severe metal loss with as much as a 30% reduction in size noted while the other handle is exhibiting as much as a 10% reduction in size.

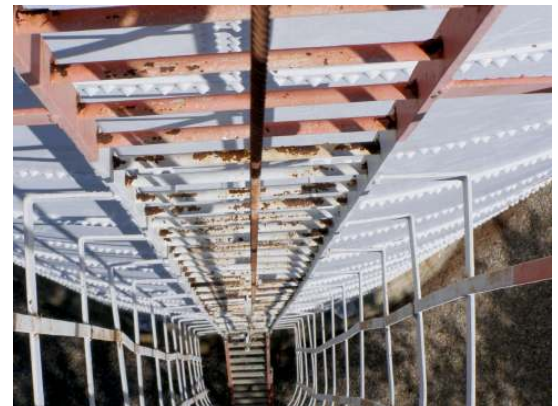
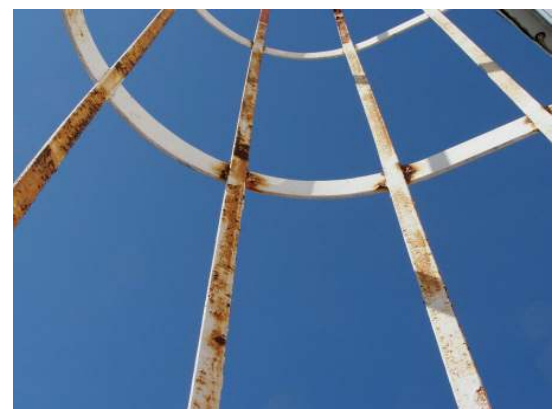
The remaining surfaces are exhibiting areas of failure primarily in the form of extensive crazed cracked and delaminated coatings which is prevalent along the ladder rungs as well as the vertical slats of the ladder cage as shown in photographs #27 and #28.

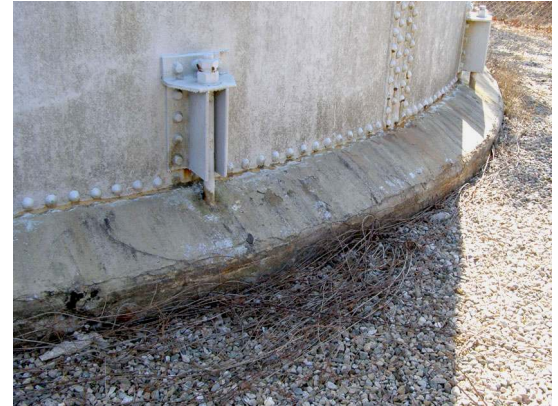
Photograph #29

**General condition of coating:** The base of the shell is encased within concrete as should in photograph #29. The exterior of the bottom transition angle was not visible for inspection. The bottom set of rivets located just above the concrete were found to be in very good condition with the exception of scattered areas of complete failure resulting in the exposure of the steel substrate surfaces and subsequent rust formation.

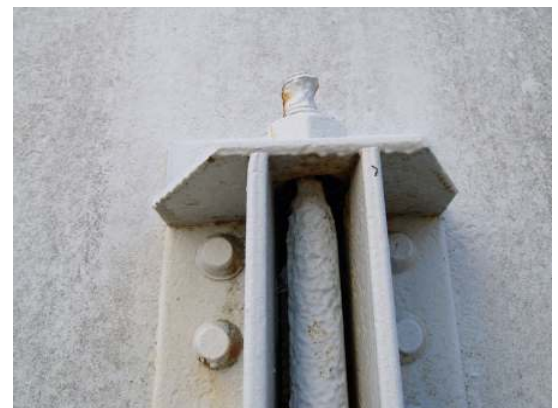
Photograph #30

**General condition of coating:** The base of the tank shell is equipped with (10)  $1\frac{1}{4}"\text{Ø} \times 20"$  tall anchor bolts secured to very narrow chair assemblies measuring  $2\frac{1}{4}"$  between the side plates. The coatings along the outboard surfaces of the anchor bolt assemblies are in generally very good condition with less than 10% of the surfaces exhibiting failure to the substrate and subsequent rust formation. The majority of this rusting is along the underside of the top plates of the chairs, edges of securing rivets as well as several of the retention nuts as shown in photograph #30.

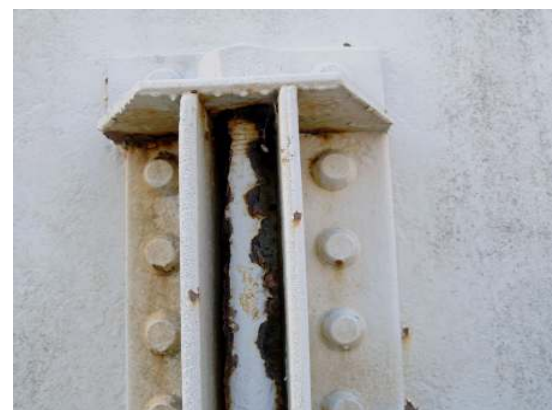
Photograph #31

The inboard surfaces of the anchor bolts and chair assemblies however, are exhibiting a much greater degree of deterioration with complete failure to the steel substrate noted along at least 50-60% of the referenced surfaces as indicated in photograph #31.

**Degree of rusting:** Rusting is primarily of a medium to heavy grade with scattered areas of stratified rust formations.

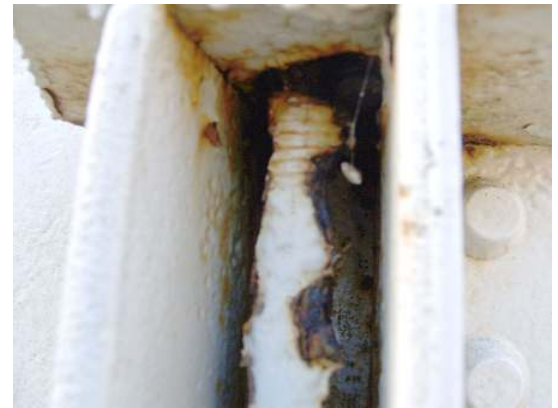
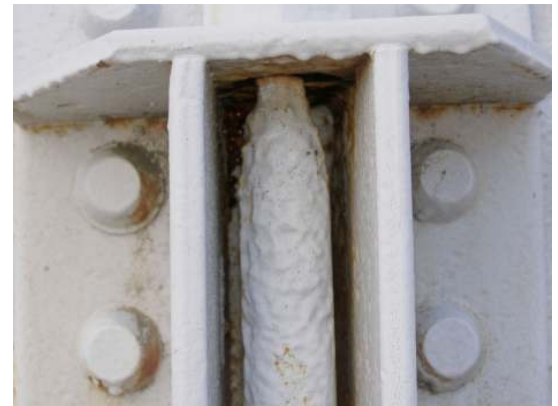
**Condition of metal:** All of the anchor bolts are exhibiting varying degrees of metal loss from both past and current corrosion ranging from a 5% to as much as a 70% reduction in thickness of the anchor bolt as shown in photographs #32 and #33.

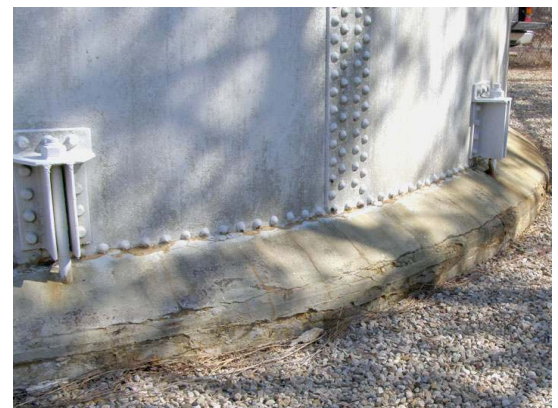
Photograph #34

**Concrete chipped or cracked:** There is evidence of degradation in the form of cracked and spalling concrete along the vertical face of the foundation; however this condition does not appear to have significantly progressed since our last inspection performed in 1997. It appears that the majority of the degradation currently taking place is of the cover coat of concrete which was applied during the last rehabilitation of the tank. This cover coat of concrete was applied along the outer cambered edge of the foundation and slopes up to the shell of the tank as shown in photograph #34.

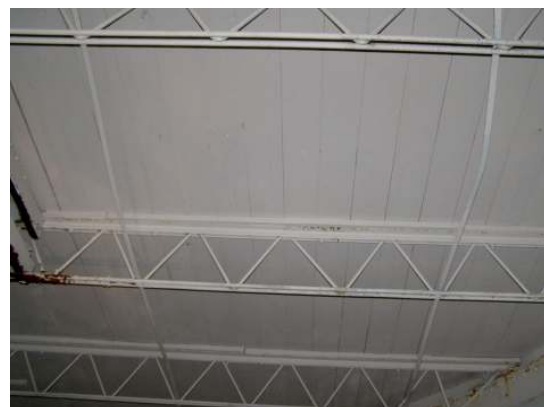
Photograph #35

**General condition:** The wood planks that comprise the roof structure were found to be in generally very good to excellent condition. There does not appear to be any significant damage or rot evident at this time. The coating on the underside of the roof planks also appears to be in good condition, with no significant failure noted as indicated in photograph #35.

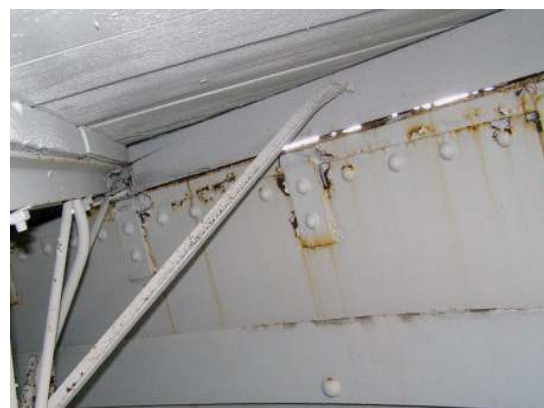
Photograph #37

**General condition of coating:** The roof to shell angle was found to be in fair condition, with the exception of heavy cracking and delamination along the top horizontal face of the angle as shown in photograph #37. This failure has resulted in light to medium rust and localized areas of heavy corrosion along at least 30% of the visible surfaces.

There are also a number of gaps present between the top face of the rim angle and the outer perimeter of the wood roof support. These gaps may be the result of failure in the mastic sealer at the junction of the top rim angle and the outer roof and most likely the source of the reported insect infiltration.

**Degree of rusting:** Rusting is affecting as much as 30% of the referenced surfaces and is primarily of a light to medium grade with localized areas of heavy rusting.

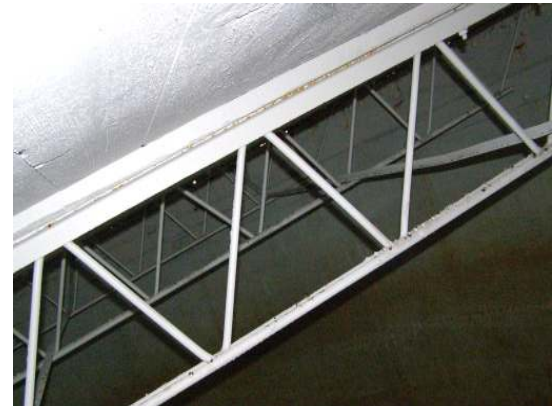
Photograph #39

**General condition of coating:** The coatings along the bar joist assemblies are in generally good condition, with at least 80% of the surfaces still being afforded reasonable protection as shown in photograph #39. The remaining surfaces are exhibiting complete failure resulting in exposure of the underlying substrate, which is now exhibiting heavy rust and stratified rust formation. The greatest degree of corrosive activity is occurring along the center truss area, which is additionally supported by four channel beams supporting the center rigging post as shown in photograph #40. This corrosive activity has resulted in heavy rust and stratified rust formations along both the top and bottom flanges of the channel beams, scattered areas of the web sections, the center post surfaces as well as the points of connections to the bar joists.

There is also evidence of stratified rust and metal loss along the ends of the bar joists where they rest atop the shell rim angle. Stratified rust is heavy in some areas, suggesting that at least moderate, if not severe, metal loss may be taking place. These areas will have to be closely assessed and descaled to determine the exact extent of metal loss, but it appears to be at least a 20% reduction in plate thickness along the associated surfaces has already resulted.

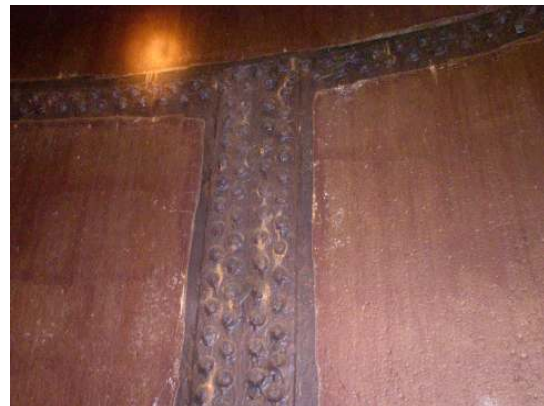
Photograph #47

**Degree of rusting:** Rusting ranges primarily between a medium to heavy grade however it is quite infrequent with less than 1% of the entire shell surfaces affected.

**Condition of metal:** Significant past metal loss was noted, with the majority of new corrosion resulting along the edges of this past deterioration. This pitting ranges from 0.100"-0.200" in depth, as recorded. The majority of the past pitting was adequately sealed by the existing paint system. Along lower shell surfaces, the majority of past pitting was shallow at 0.050"-0.075" however scattered deep pitting measuring 0.5"-1" in diameter and 0.150"-0.210" in depth was observed. These deep pits are present at a frequency of less than 20-25 per shell ring. Refer to the summary sheet for detailed information regarding both active and past metal loss along the shell surfaces.

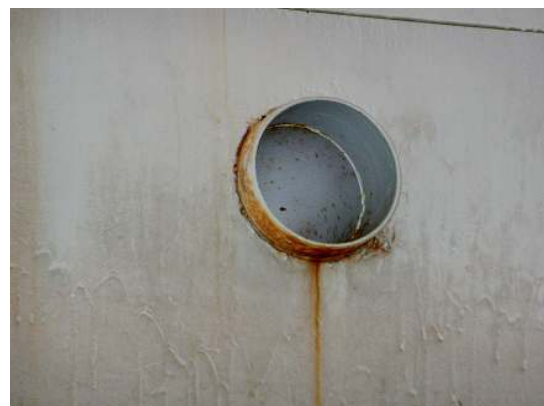
Photograph #51

**General condition of coating:** The coating along the interior section of overflow which extends into the tank as shown in photograph #51 is in poor condition along the exterior surfaces, with significant rusting taking place along at least 70% of visible surfaces. The coating along the inboard surfaces is significantly better with only localized rusting evident. There is only minor corrosion and rust staining emanating from the unsealed junction of the overflow pipe and the shell wall.

**Degree of rusting:** Rusting is of a light to medium grade and is affecting at least 70% of the exterior surfaces and 5% of the visible interior surfaces.

**Condition of metal:** There was no evidence of any appreciable metal loss taking place.

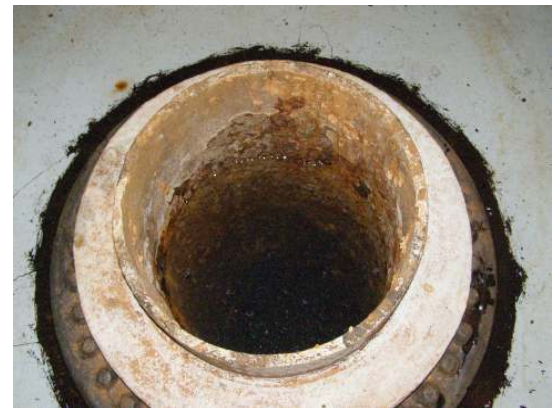
Photograph #58

**General condition of coating:** The coating along the exterior surfaces is in generally good condition with only scattered areas of medium to heavy rusting observed along less than 2% of the referenced surfaces. Heavy tuberculation was observed along the majority of all interior surfaces of the fill line.

**Degree of rusting:** Medium to heavy along less than 2% of exterior surfaces and at least 80% of visible interior surfaces.

**Condition of metal:** There was no measurable metal loss along the exterior surfaces of the fill line assembly however there appears to be at least slight to moderate metal loss along the interior surfaces of the pipe as shown in photograph #58.

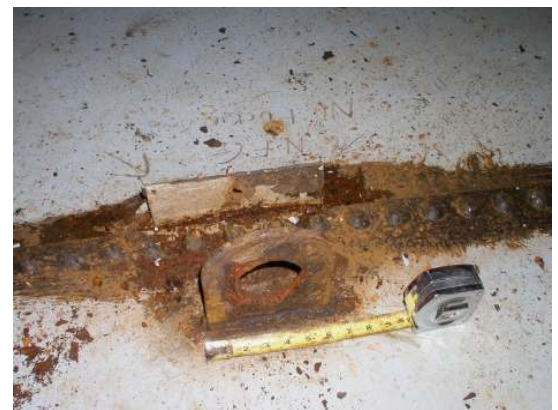
Photograph #59

**Type:** There are two rigging lugs welded to the center floor area as shown in photograph #59.

**General condition of coating:** The coatings along these two items are in poor condition with extensive failure and subsequent rusting taking place along the majority of all surfaces.

**Degree of rusting:** Rusting is of a medium to heavy grade affecting at least 90% of the referenced surfaces.
